# Preliminary Results of the Investigation into Self Actuation of Light Switches during Fire Exposure

# Self Actuation of Light Switches during Fire Exposure

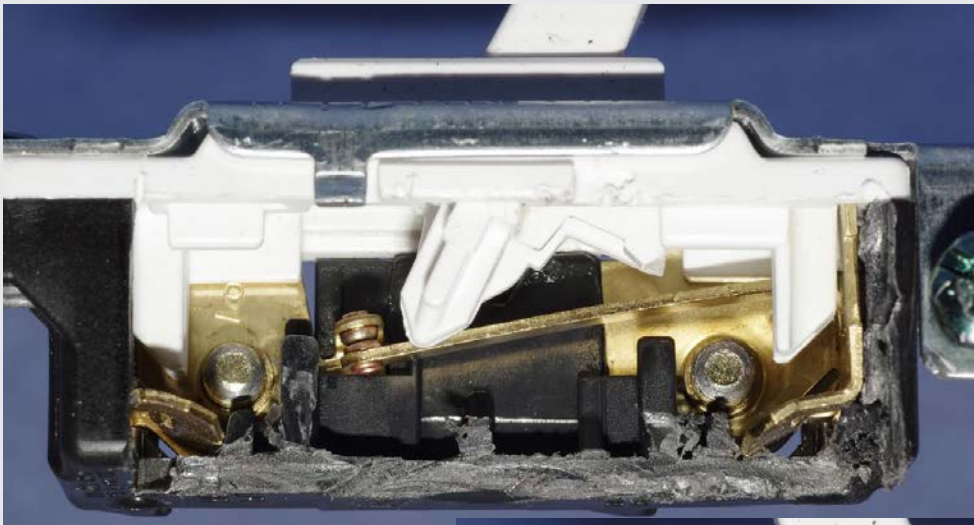
*Typical Single Pole Residential Switch in the ON Position*

Most single pole light switches have two main copper alloy (typically brass) parts. The smaller piece holds the fixed electrical contact and also usually has a screw terminal for connecting to the building wiring. The larger piece also has a screw terminal and also has a copper alloy contact beam or arm which has the movable contact at one end. These two brass parts are mounted inside a polymer housing referred to here as the switch body. When these parts are properly mounted in the switch body, the contact beam has enough spring force built in to apply pressure to close the electrical contacts. It is important to note that in the absence of any intervening forces, the contacts

are in the “ON” (closed) position. When the switch is in the “ON” position, the beam moves over and presses the contacts closed, allowing electrical current to flow through the switch and complete the circuit.

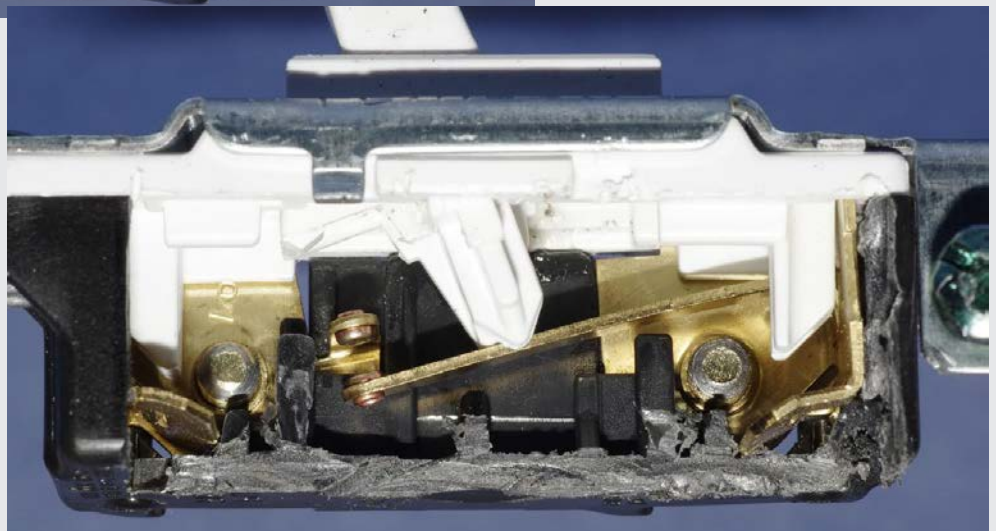
*Typical Single Pole Residential Switch in the OFF Position*

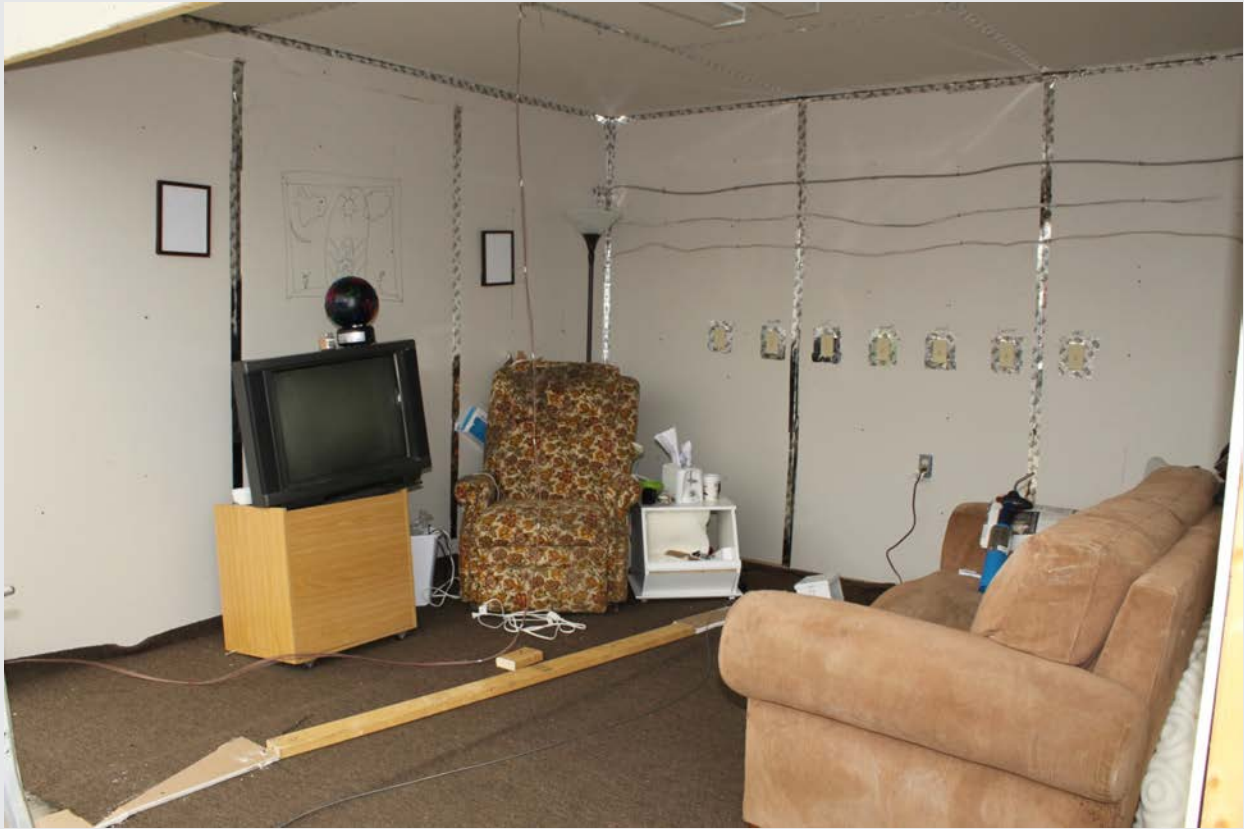
Colonie, NY Test Burn Pod –

Note Light Switches on Back Wall. Switch #1 is the Right Most Switch  
in the Back Wall

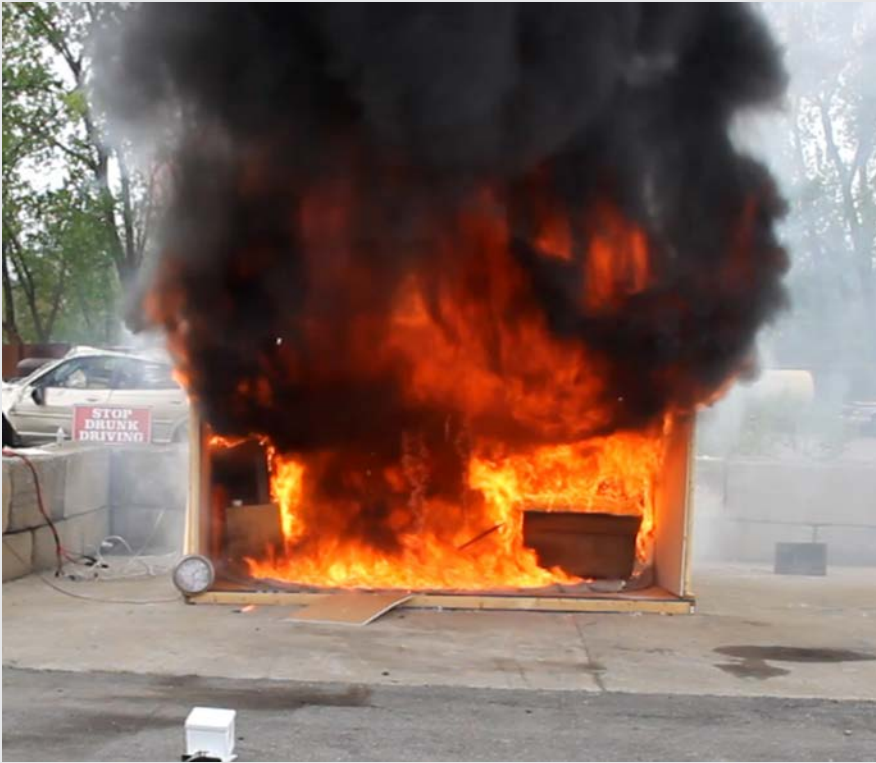
Colonie, NY  
Test Burn Pod Fire

Comparison of Fire Damaged  
Switch #1 from Colonie, NY  
Test Burn Pod (Bottom)  
and New Exemplar in the  
OFF Position (top)

The post fire condition of the switches varied widely. Some of the switches that self-actuated were sufficiently damaged by the heat from the compartment fire that their pre-fire switch position could not be determined. X-ray examination of the switches in which their polymer body was still intact post fire revealed sufficient detail to determine the position of the over center snap action spring and often the internal levers from the switch handle. X-rays of four of the relatively intact switches that had self-actuated revealed that the over center snap action spring and interior lever position were clearly still in the off position. The same x-rays revealed that while the internal components of the switch were in the off position, the electrical contacts were closed and thus the switch was capable of conducting electricity from one screw terminal to another. Destructive disassembly of several of the switches that self-actuated revealed that the polymer face piece and toggle assembly had softened resulting in them being unable to withstand the closure force from the brass contact beam. Thus the brass beam containing the movable contact was able to push outwards towards the fire compartment interior resulting in the contacts closing.
